Client – Transnet – Duration of work 12 Days (Test) – Workman on sight 12. SQM of Crane 3620. New steel 8 tons

STRUCTURAL REFURBISHMENT

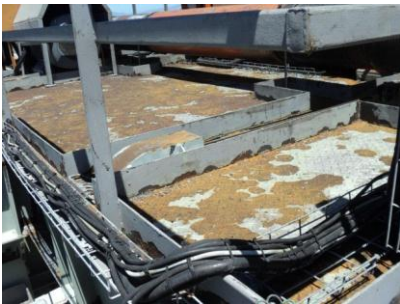
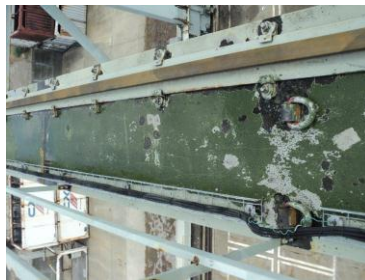
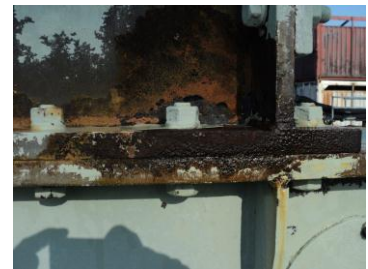
Corrosion on crane

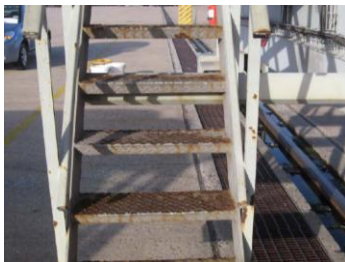
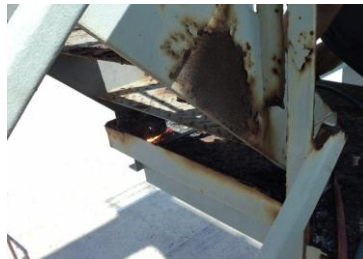
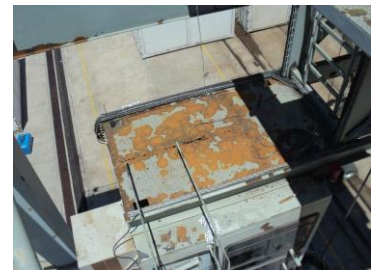
Corrosion on crane

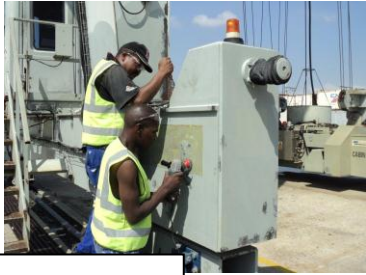
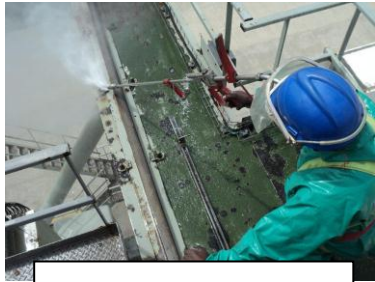
High pressure cleaning

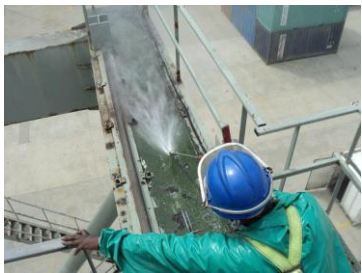
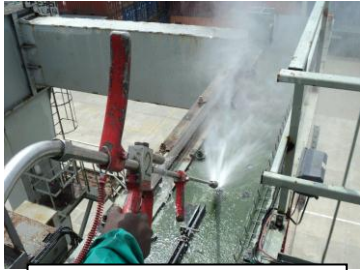
High pressure cleaning

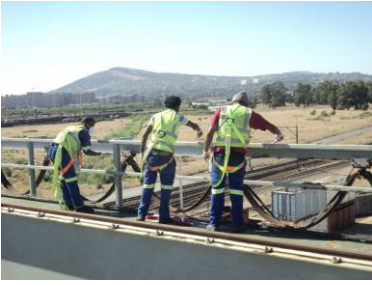
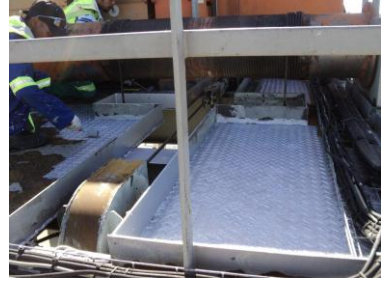
Rolling Rustbullet onto walkways

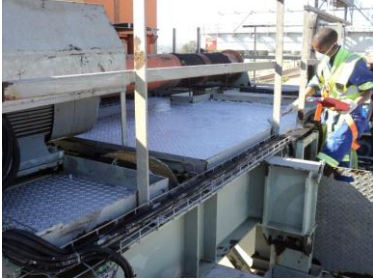
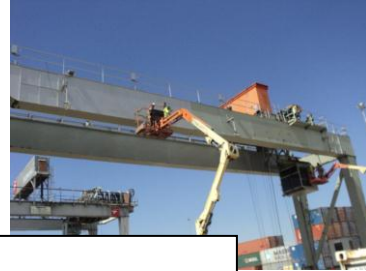
**Spraying Rustbullet onto columns,
using piston spray machine
2400psi.**

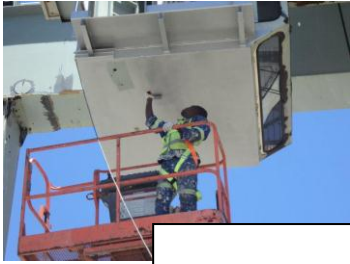
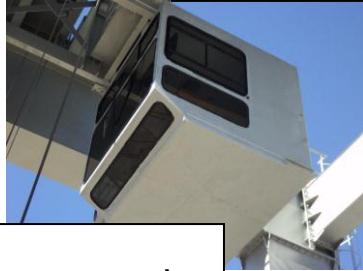
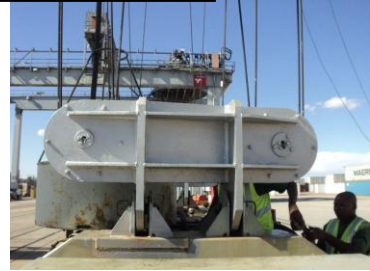
**Rolling Rustbullet onto control
cabin, using foam rollers**

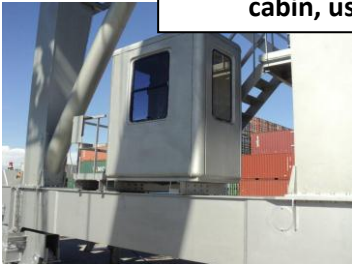
**Putting signage back onto crane
after completion**
