Project Description:

The Chief Joseph Dam is a concrete gravity dam on the Columbia River in Northwestern United States, 1.5 miles upriver from Bridgeport, Washington. The dam is 545 miles upriver from the mouth of the Columbia at Astoria, Washington. The Dam is operated by the United States Army Corp of Engineers (USACE) Chief Joseph Dam Project Office. The Chief Joseph Dam is the second largest hydroelectric power producer in the United States, having the hydraulic capacity of 6,030 m³/s (213,000 cf/s). The electricity generated at the Dam is marketed by the Bonneville Power Administration.

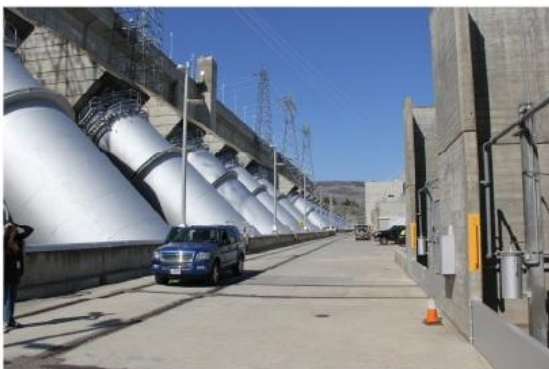
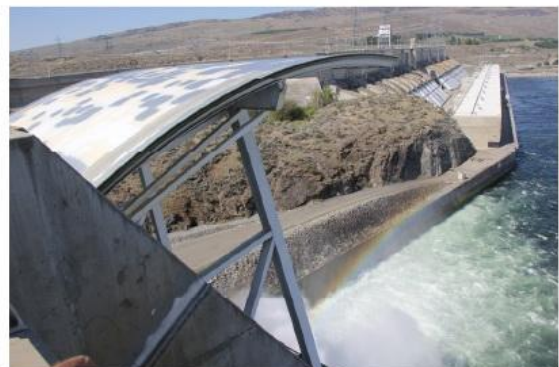
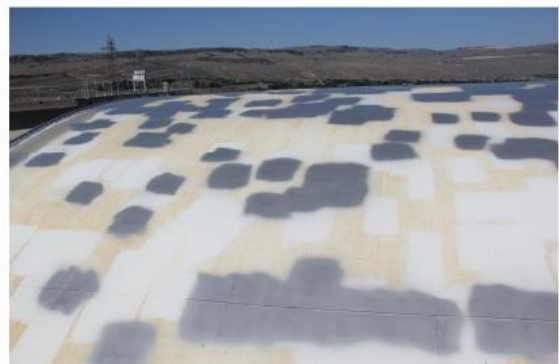
The 27 pieces of electrical machinery located above one of the Turbines are already scheduled for coating with Rust Bullet. Similar machinery that was not coated with Rust Bullet is exhibiting coating failure due to the exposure to extreme atmospheric conditions of moisture and UV rays. The painting and maintenance crew now insist on using rust bullet and have stated that they would personally promote Rust Bullet to any industrial painter who is has to deal with corrosion control.
